EFFECT OF MATRIX RESIN ON THE IMPACT FRACTURE CHARACTERISTICS
OF GRAPHITE-EPOXY LAMINATES

NASA Contractor Report 165784

P. E. Hertzberg, B. W. Smith, and A. G. Miller

Boeing Commercial Airplane Company
Seattle, Washington

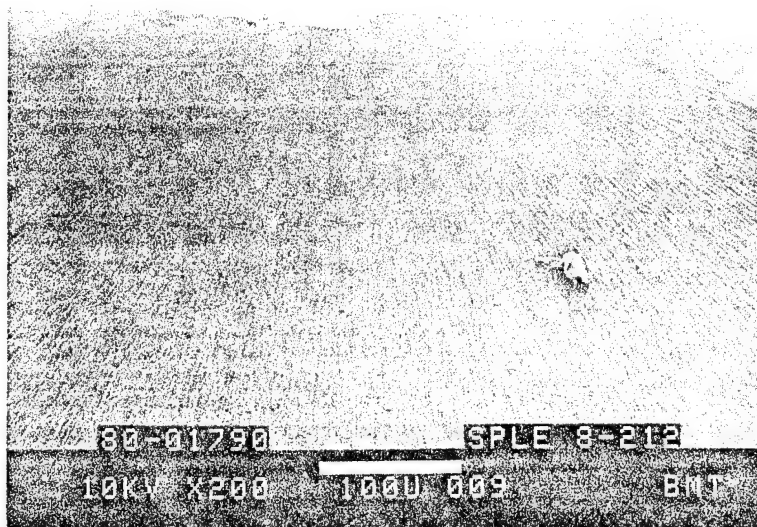
Figure 7. Neat Resin Fracture, Narmco 5208 (200X)

Narmco 5208 (fig. 7) is a tetraglycidylmethyle dianiline (TGMDA)-diaminodiphenylsulfone (DDS), 177°C (350°F) curing epoxy with good high-temperature properties, low strain to failure, and brittle fracture behavior. This brittle behavior is manifested in the smooth, glassy cleavage planes found in the fracture face, as well as the well-defined origin zones and transverse cleavage planes perpendicular to the direction of crack propagation. Figure 7 describes the classically brittle case, and the features seen at low magnification continue as increasing magnification is used (figs. 9 and 10). There is little ductility in this material and no deliberate introduction of second-phase elastomer or elastomer modification of any kind.

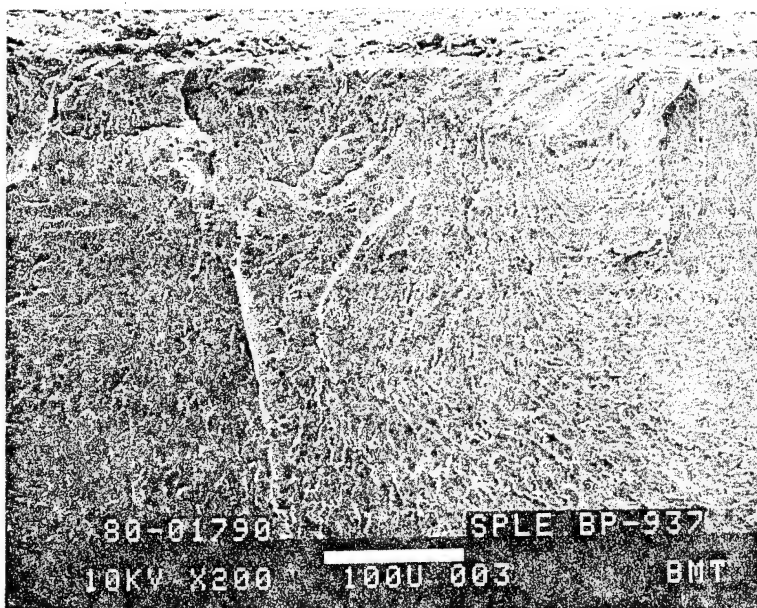
Figure 8. Neat Resin Fracture, Cycom 937 (200X)

Cycom 937 (fig. 8) is a highly elastomer-modified epoxy, using a different base resin, bisphenol-A, and several different elastomer additions. Because of these additions, Cycom 937 has a much lower T_g than Narmco 5208, 121°C (250°F) versus 177°C (350°F), even though both are cured at 177°C (350°F). The elastomeric modification gives Cycom 937 a much higher strain to failure and the ability to sustain some plastic flow before ultimate rupture. This is seen in the lack of a clearly defined origin zone and the absence of transverse cleavage planes found in Narmco 5208. These features are obliterated by the ductile flow of Cycom 937 prior to failure. In addition, much

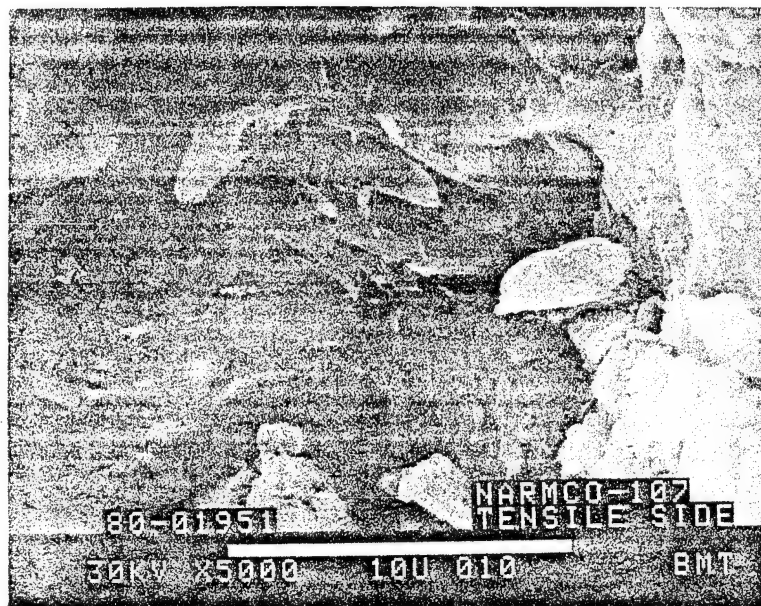
Note flow lines in resin

Figure 43. Flow of Resin Under Shear Loads, Narmco 107 (5000X)

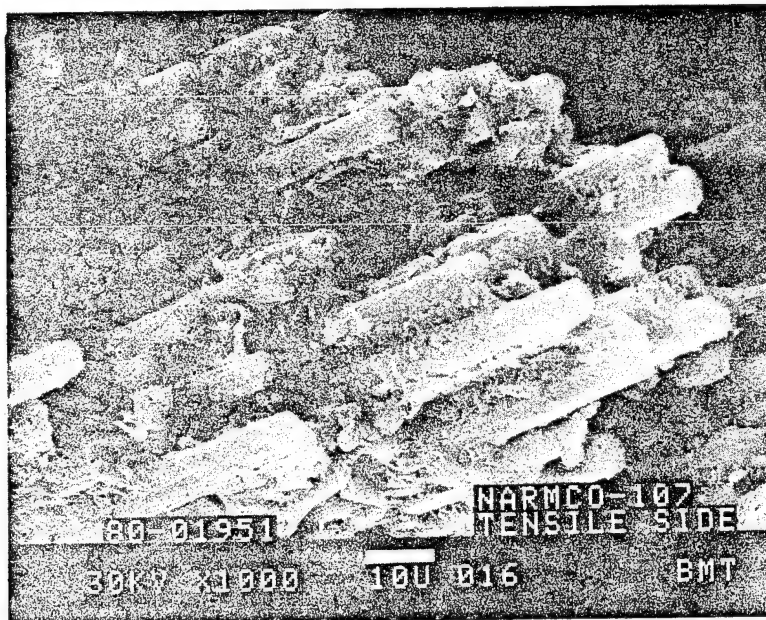
Resin-to-fiber bonding (fig. 45) in this system is quite good, with pulled-out fibers and those with cracks close to the outer fiber surfaces being covered with a thick coating of resin. This is especially well illustrated in Figure 46.

Figure 45. Resin-Fiber Bonds, Narmco 107 (1000X)

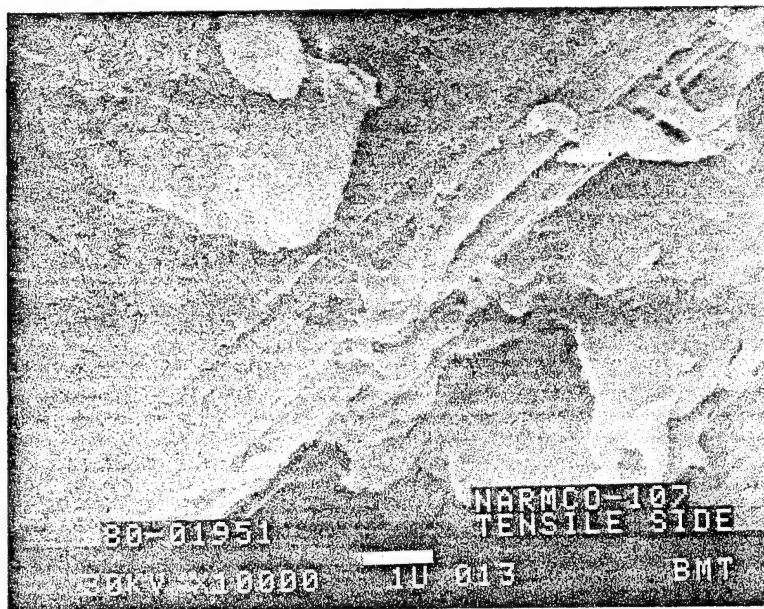
Figure 46. Resin-Fiber Bonds, Narmco 107 (10,000X)

Note resin deformation.

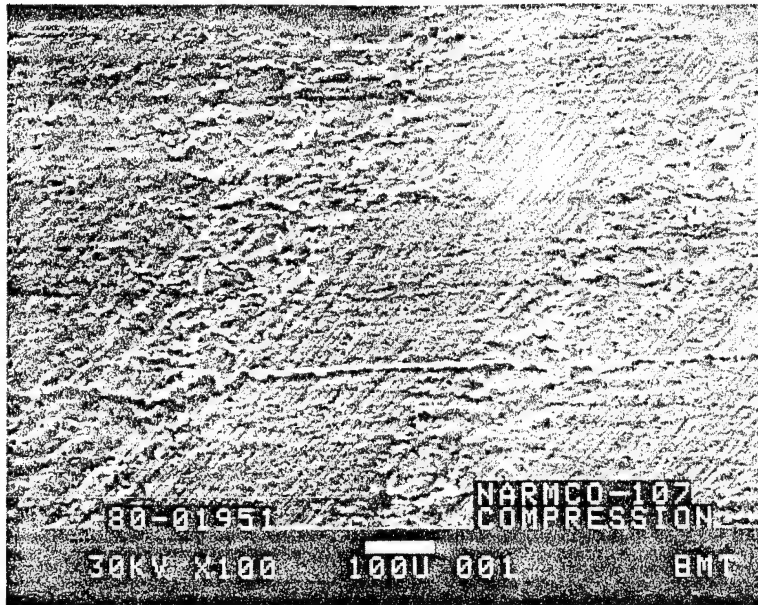
Compression and compression shear faces are shown at comparative magnifications in Figures 47 through 50. These photographs show that the shear deformations, compared to the tension side of the fractures, are caused by the same basic mechanism and produce the same type of fracture appearance. The transply deformations, when viewed in a broken 90-deg ply, show characteristic compression features on the macroscopic level. Figure 51 shows a rare patch of undamaged compression failure surface in the center-right side of the photograph. It is interesting to compare the area of well-defined hackles and the stretching of the broken resin in the area of nonsmeared fracture, to the far more typical appearance of the rest of the photograph. This smoother, flowed appearance is characteristic of neat resin composite compression failures and is a result of separated ply movement after crack formation. The direction of gross separated ply movement in this photograph is to the left, while the actual crack propagated to the right.

Figure 47. Compression-Loaded Shear, Narmco 107 (100X)

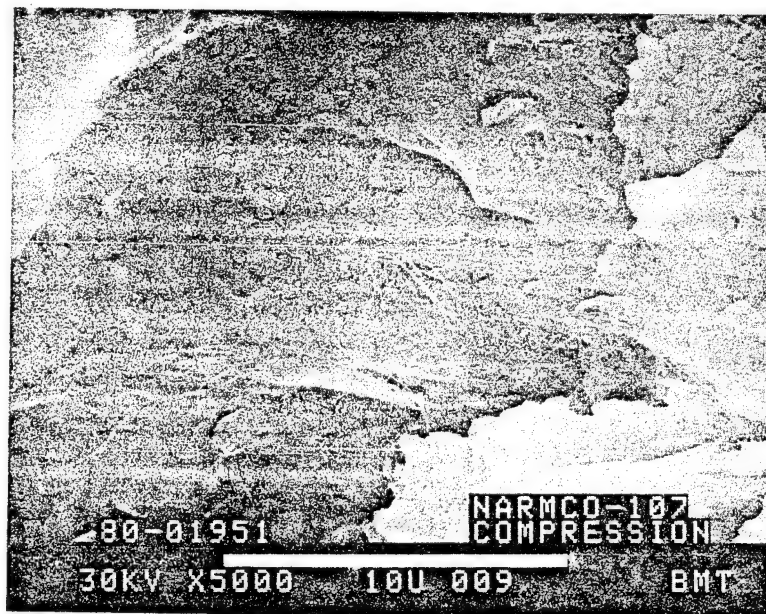
Figure 52 shows the hairy resin failure appearance first noted on the tension side. This feature is far more pronounced on the compression side and clearly shows the direction of plastic flow during the deformation process. These hairs are shown in higher magnification in Figure 53, which also shows the roots extruded from the base resin into a filament and, in some cases, bridging a gap between two large blocks of resin.

Figure 52. Hairy Skin Fracture Appearance, Shear-Loaded, Narmco 107 (5000X)

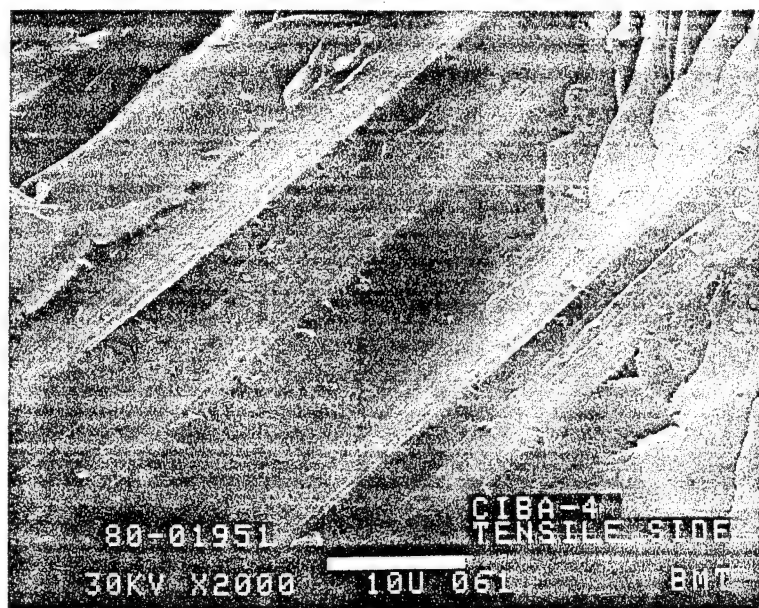
Resin tension fracture, viewed from a transverse crack in a tension-loaded 90-deg ply, is shown in Figures 59 and 60. As in the case of the shear appearance, the ultimate separation mechanism is cleavage. However, plastic flow of the bulk materials appears to have occurred before separation. This is evident when Figures 59 and 60 are compared to Figures 61 and 62, a 90-deg tension failure of Narmco 5208. Care must be taken when making comparisons due to the different magnifications, but the similarity of features is evident.

Figure 59. Resin Tension Fracture, Ciba 4 (2000X)

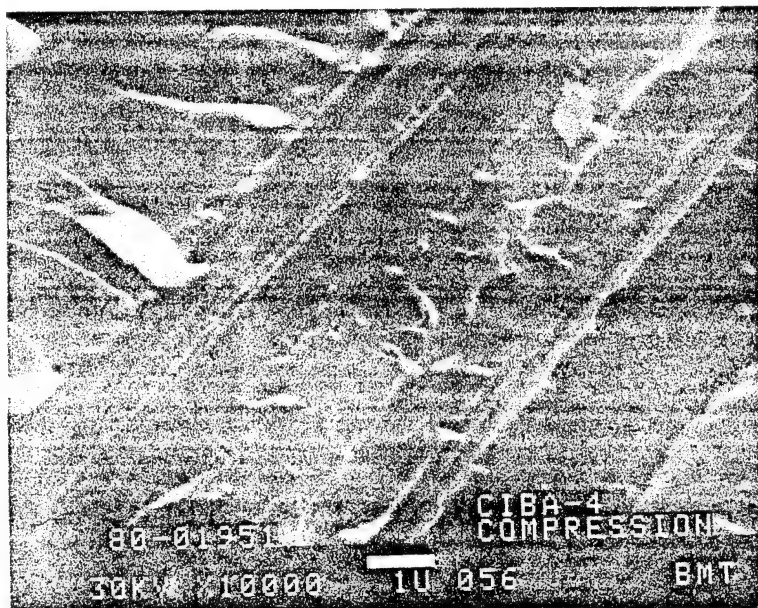
Fiber-matrix bonding is quite good in Ciba 4. The high magnification necessary to view fiber-matrix interaction also is necessary to resolve indications of plastic deformation and second resin addition. The small bumps on the fibers shown in Figures 63 and 64 are similar to those seen in Air Logistics 1, and the intersections of the cleavage planes have stretched and thinned resin streamers, characteristic of necked and failed material.

Figure 63. Fiber-Matrix Bond, Ciba 4 (10,000X)

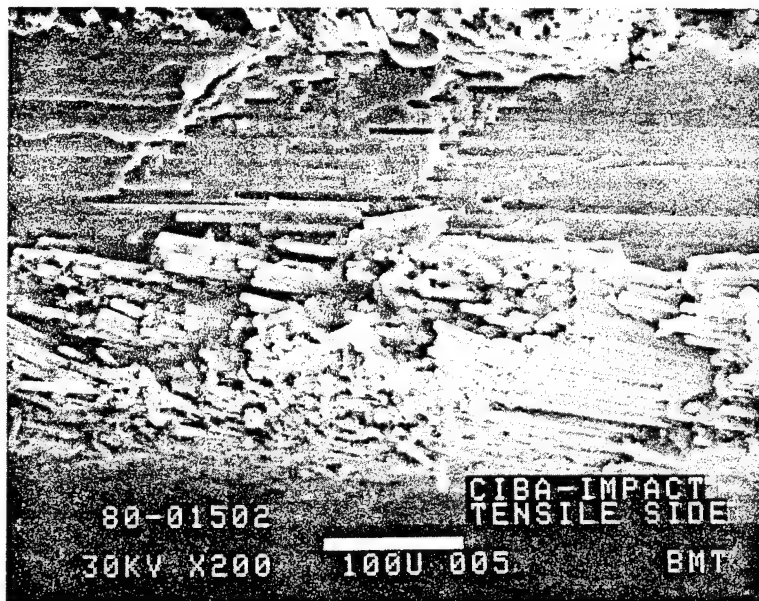
Figure 68. Typical Crossply Failure, Significant Pullout, Ciba 1M (200X)

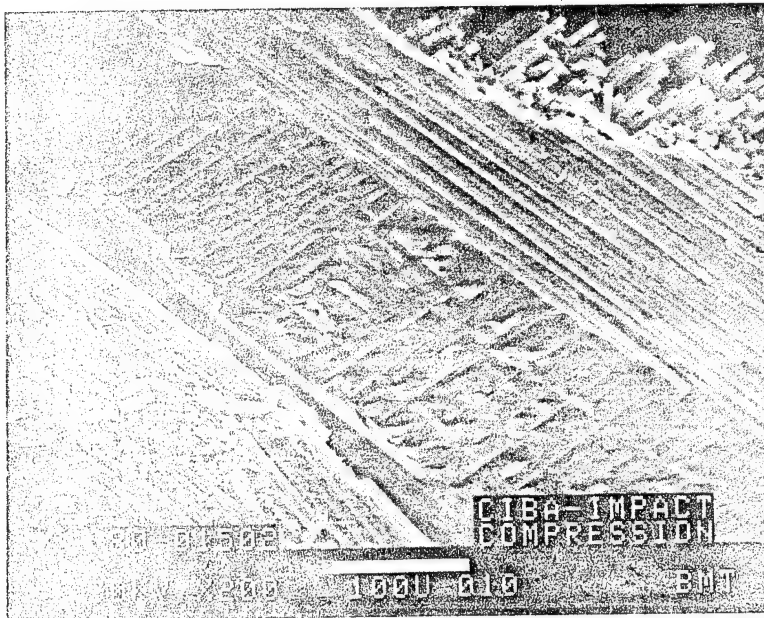
Figure 73. Neutral Axis, Ciba 1M (200X)

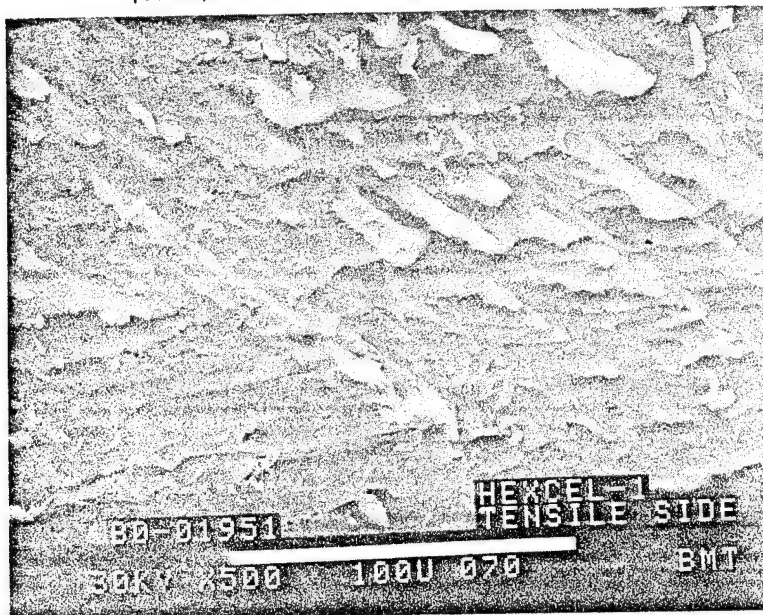
The ductility of the base resin is obvious from Figures 78 through 84. Figure 84 shows resin elongation on the order of $10 \mu\text{m}$ at 5000X, which is conspicuously absent in the case of the nonductile systems.

Figure 78. Plastic Flow on Shear Interlaminar Plane, Hexcel 1 (500X)

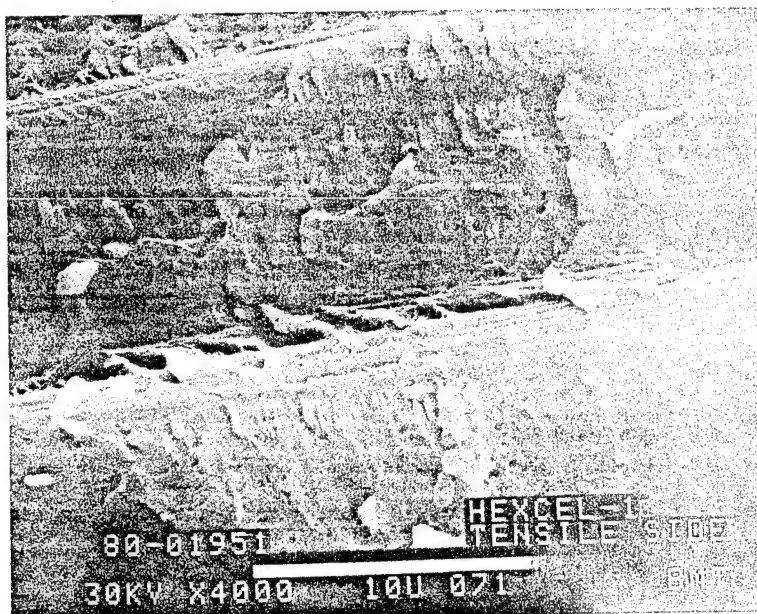
The pit size distribution remains narrow throughout the specimen, as can be seen by comparing Figures 79 and 80 with Figures 81 and 82, which are photographs of a corresponding shear plane from the compression side of the specimen and exhibit the same pitted appearance. The pits conform to the plastic flow directions of the base resin, which supports the supposition that the pits are voids, or at least were created before the ultimate separation of the fracture faces.

Fiber-matrix bonding of Hexcel I seems to be adequate for the impact case. This is shown in Figures 79 and 81. The conditions shown in these photographs are typical of the entire fracture appearance.

Figure 79. Good Resin Ductility, Transverse Tension Loading, Hexcel 1 (4000X)

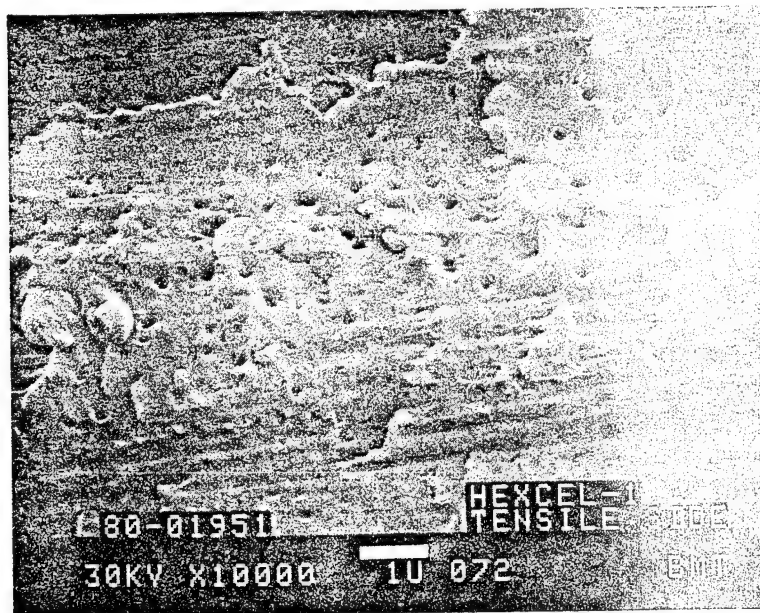
Figure 80. Resin Flow With Pits, Hexcel 1 (10,000X)

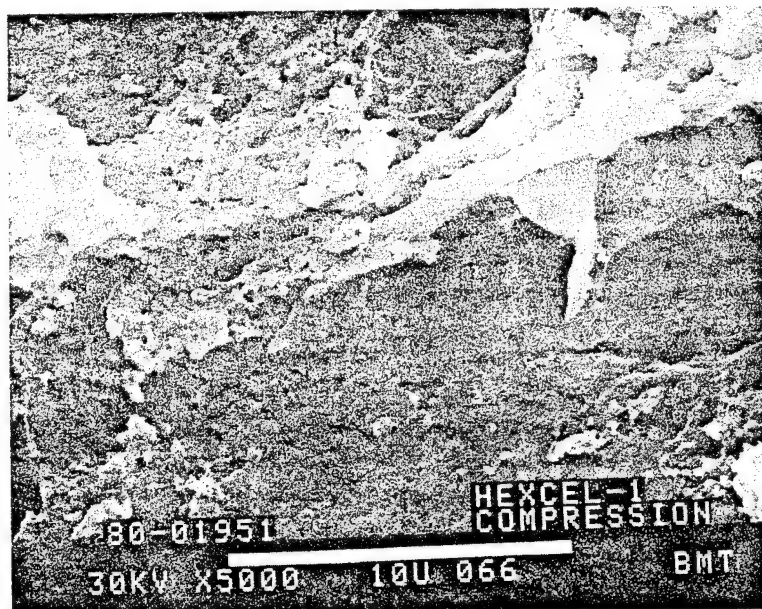
Figure 84. Resin Flow, Different Area, Hexcel 1 (5000X)

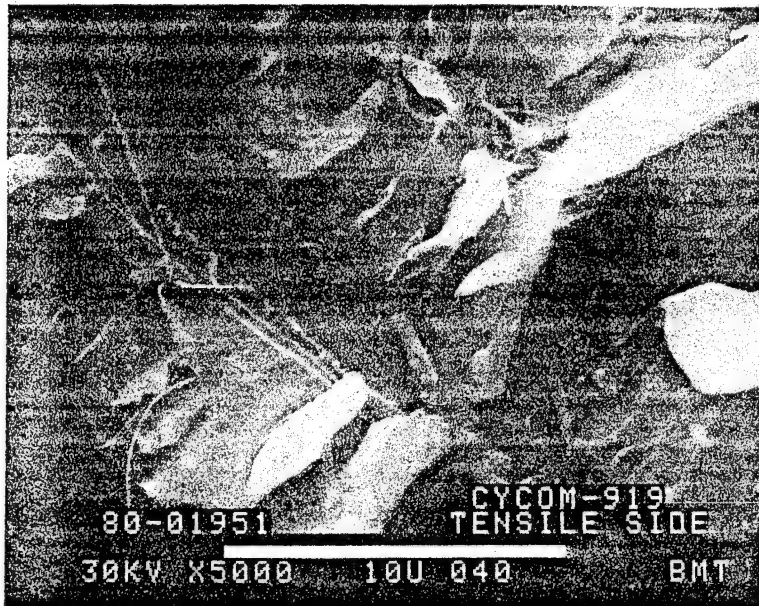
this feature is shown in Figure 87. This magnification reveals the fact that plastic deformation of the resin does occur in this material. This deformation is similar to that of several other specimens used in this study and consists of stretching and feathering of the hackles formed by the intersection of opposing cleavage facets. Several different areas are shown in Figures 88 and 89.

Figure 87. Hairy Appearance, Resin Whiskers, Cycom 937 (5000X)

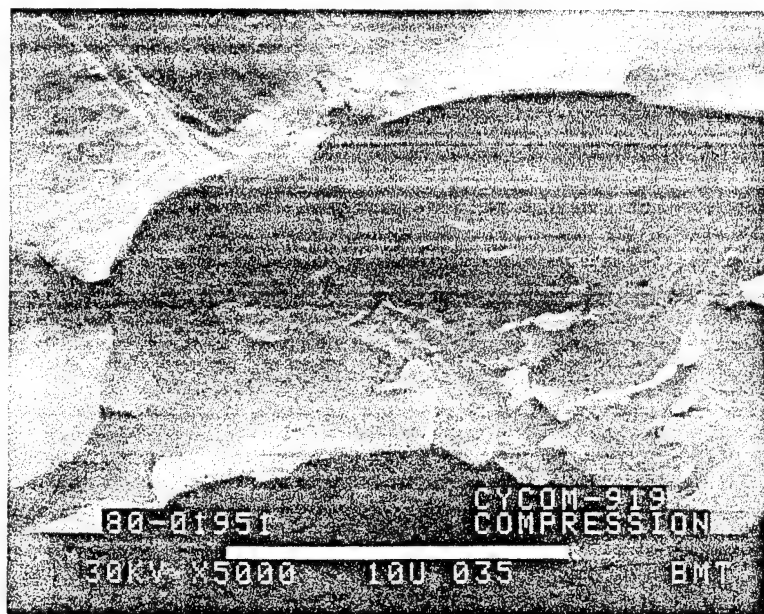
Fiber-matrix bonding is adequate in Cycom 919, as shown in Figures 90, 91, and 92. The fiber surfaces shown in this figure are coated with a thin layer of resin, some of which is plastically deformed.

Figure 91. Resin-Fiber Bond, Cycom 919 (5000X)

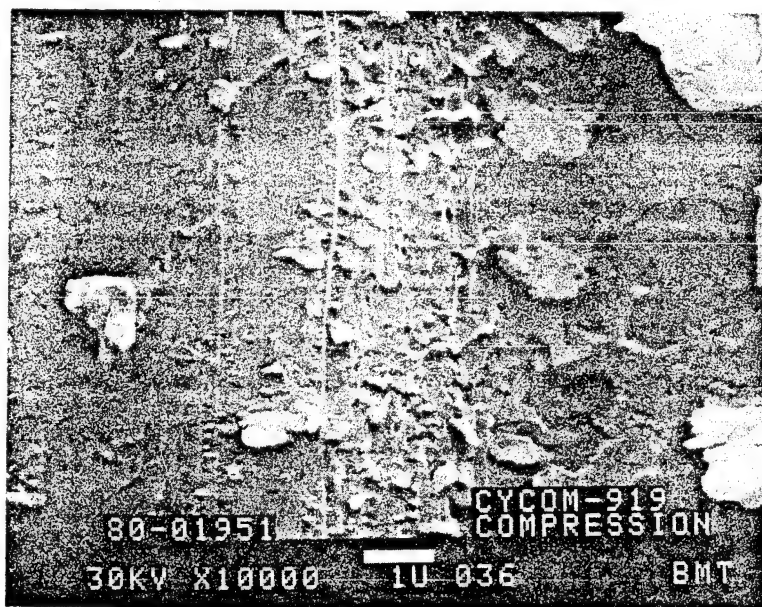
Figure 92. Resin-Fiber Bond, Exposed Fibers, Cycom 919 (10,000X)

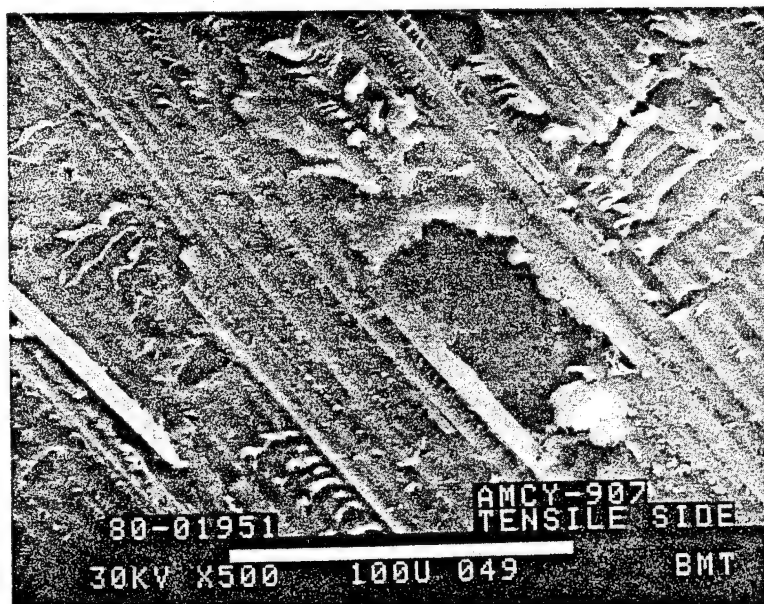
Higher magnification views of voids and void-free surfaces are shown in Figures 95 and 96. The amount of plastic deformation is much greater in the material with higher resin content. This trend continues with the higher magnification views (figs. 97 and 98). These photographs graphically show the different extent of deformation created by the presence of additional resin.

Note: Same area as figure 94.

Figure 96. Delamination Face, BP-907-LR (500X)

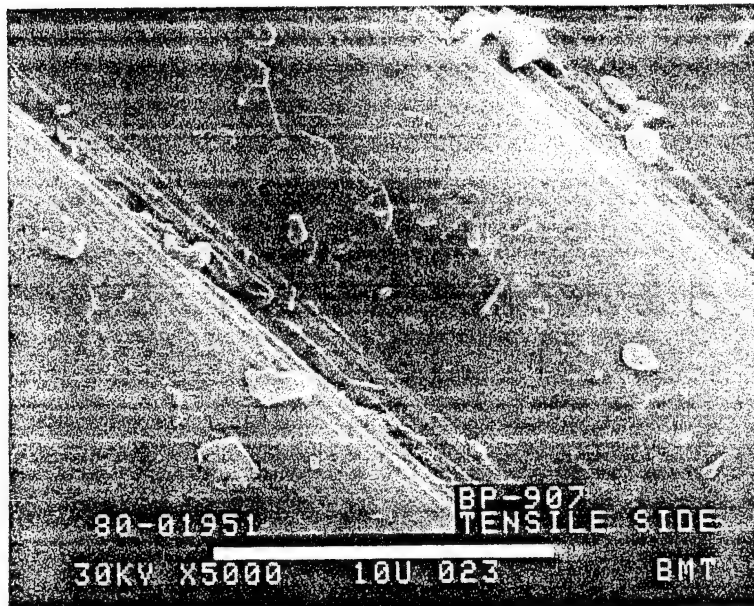
The basic microscopic fracture mechanism appears to be the same in both the high- and low-resin-content materials. This conclusion is based on comparison of the two photographs in Figures 99 and 100. However, the fact that insufficient material may be available for the complete operation of this fracture mechanism may impair its efficiency as a toughening agent, as shown by Figures 101 and 102. The elongation of the resin under stress is clearly shown by Figure 102, but the formation of the large, deformed bodies seems to require the presence of greater amounts of resin. This would be manifested in an apparent increase of impact toughness, since the energy required to deform greater amounts of resin would necessarily be higher than that required for a lesser amount of the same resin.

Figure 99. Microscopic Fracture Mechanism, BP-907 (5000X)

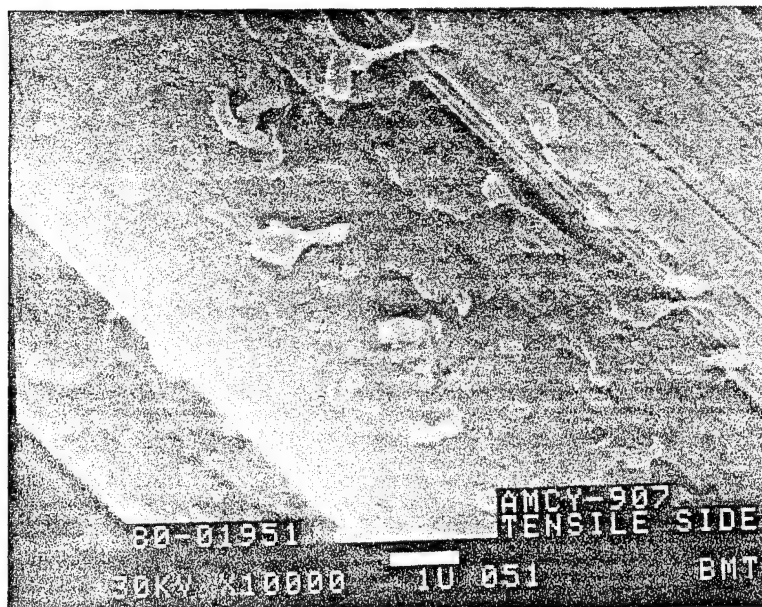
Figures 101 and 102 also show that the interface properties of BP-907 are not affected by resin content and that complete wetting of the fibers occurs despite the lower resin content of BP-907-LR.

Figure 102. Resin-Fiber Bond, BP-907-LR (10,000X)

Note lack of large ductile flow.

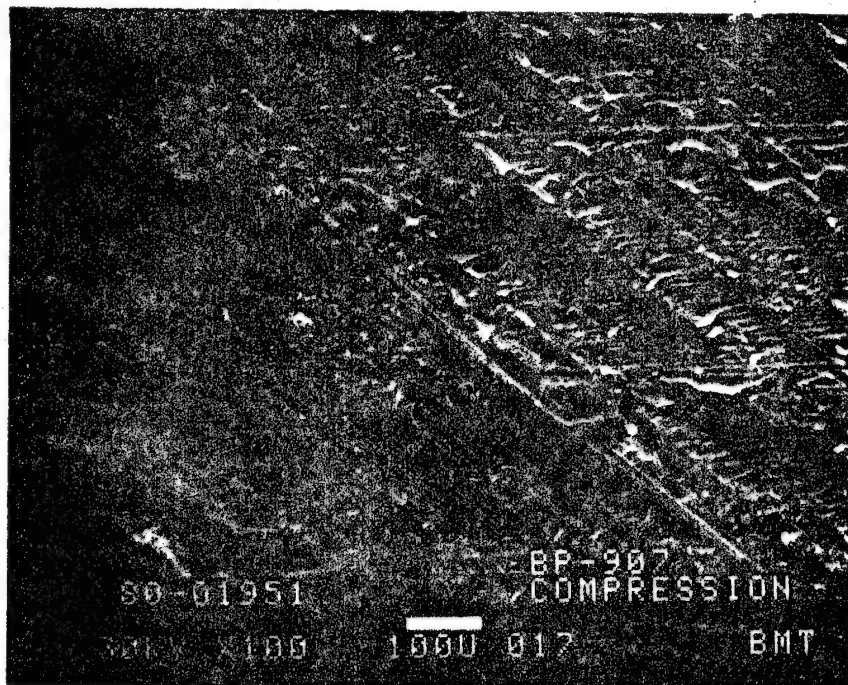
The differences in apparent ductility also extend to the compression-loaded interfaces. This is seen in Figures 103 through 108. These photographs show, as on the tension side, that the same deformation mechanism applies to the entire specimen, but that the lower resin content reduces the material available for this mechanism to act on. This would result in a lower apparent toughness for the materials with lower resin content.

Figure 103. Compression-Loaded Shear Delamination, BP-907
(100X)

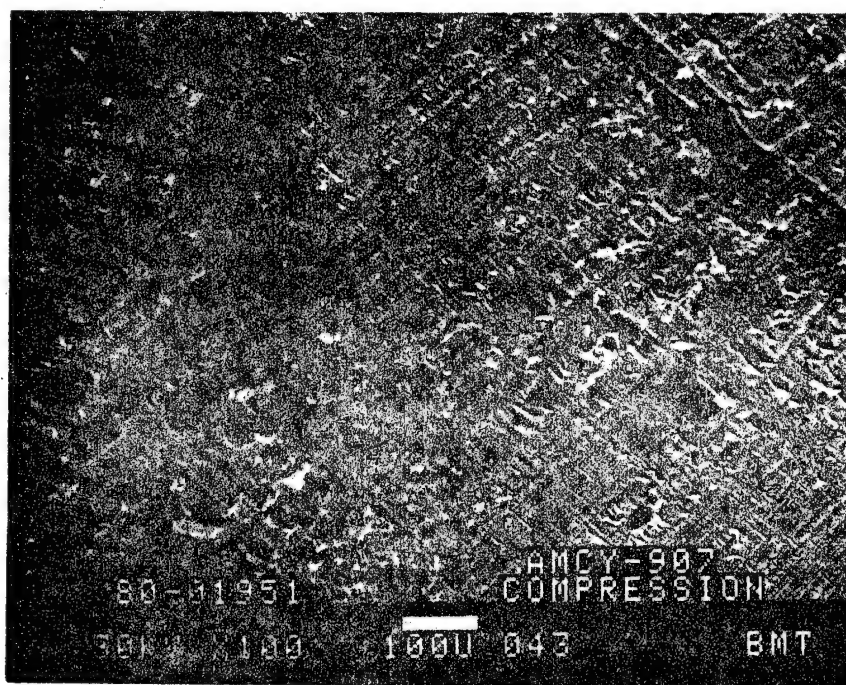
Figure 104. Compression-Loaded Shear Delamination, BP-907-LR
(100X)

Note: Similar face to figure 103.

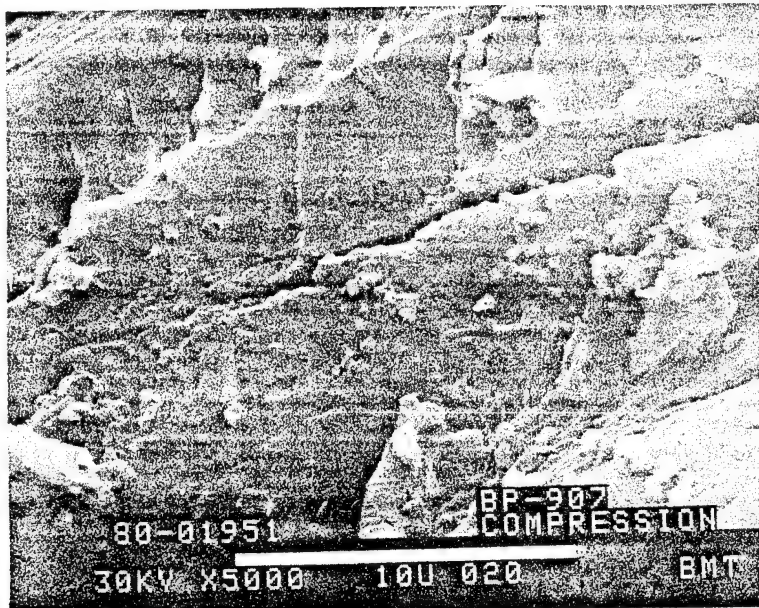
Figure 107. Microscopic Fracture Appearance, BP-907 (5000X)

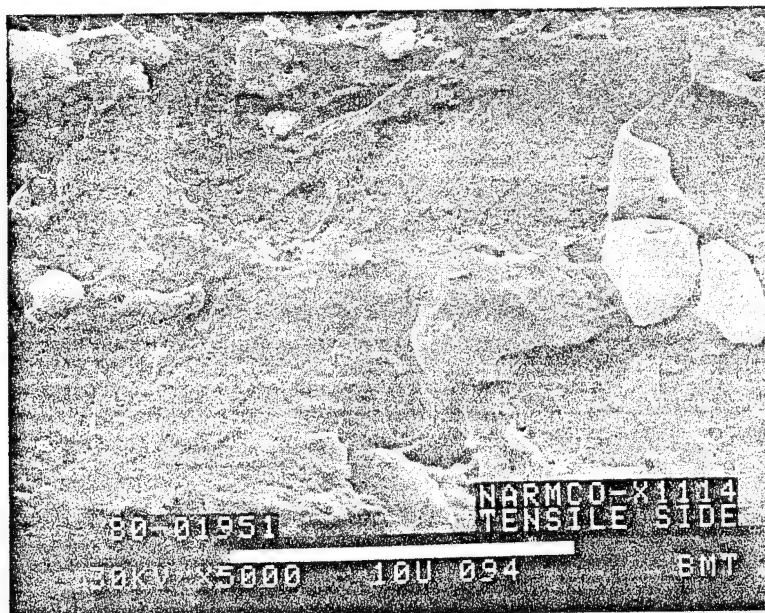
Considerable plastic flow is indeed found upon examination of the separated surfaces. This deformation is shown in Figures 109 through 114. These photographs, particularly Figures 111 through 114, show that there is virtually no brittle fracture or cleavage on the fracture planes. All of the resin shows an almost gummy appearance, as if capable of extreme strain. The fact that this composite has a T_g of only 46°C (114°F) may be a factor in this extreme plastic flow. Figure 114 shows that bonding to the fibers is extremely good for this system, and Figure 113 shows that even tension fiber failure does not translate into a failure of the surrounding resin.

Figure 114. Fiber-Matrix Bond, Narmco X1114 (5000X)

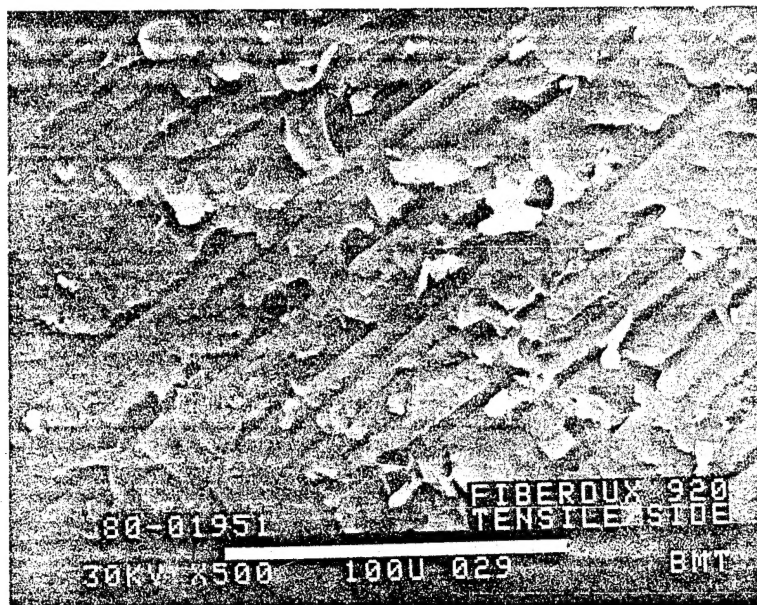
Figures 123 and 124 show this delamination surface at higher magnification. Figure 123 reveals that there are few, if any, fracture details that would suggest any kind of brittle fracture or cleavage and shows that this resin apparently fails by ductile tearing only. However, Figure 124 shows a crack propagating through the resin after a tension fiber failure, indicating that this material will support crack propagation under the proper conditions. The fiber-matrix bond also is revealed in this photograph, and it is significant that the crack propagates exclusively through the resin, and not along the interface. Figure 125 is a similar photograph taken from the other side of the specimen and shows a similar appearance, in that the bare fiber surface is not exposed. Figures 126 and 127 should be compared to Figures 122 and 123, respectively. These figures show good agreement with respect to the fracture topography and confirm that the shear mechanism operating in the interlaminar spacing of this material is consistent throughout the thickness.

Figure 123. Ductile Flow Around Fibers at Interlaminar Boundary, Fibredux 920 (500X)
